THE REA LINEMAN

RURAL ELECTRIFICATION ADMINISTRATION

Vol. VII, No. 5

Wrong Disconnection Causes Accident

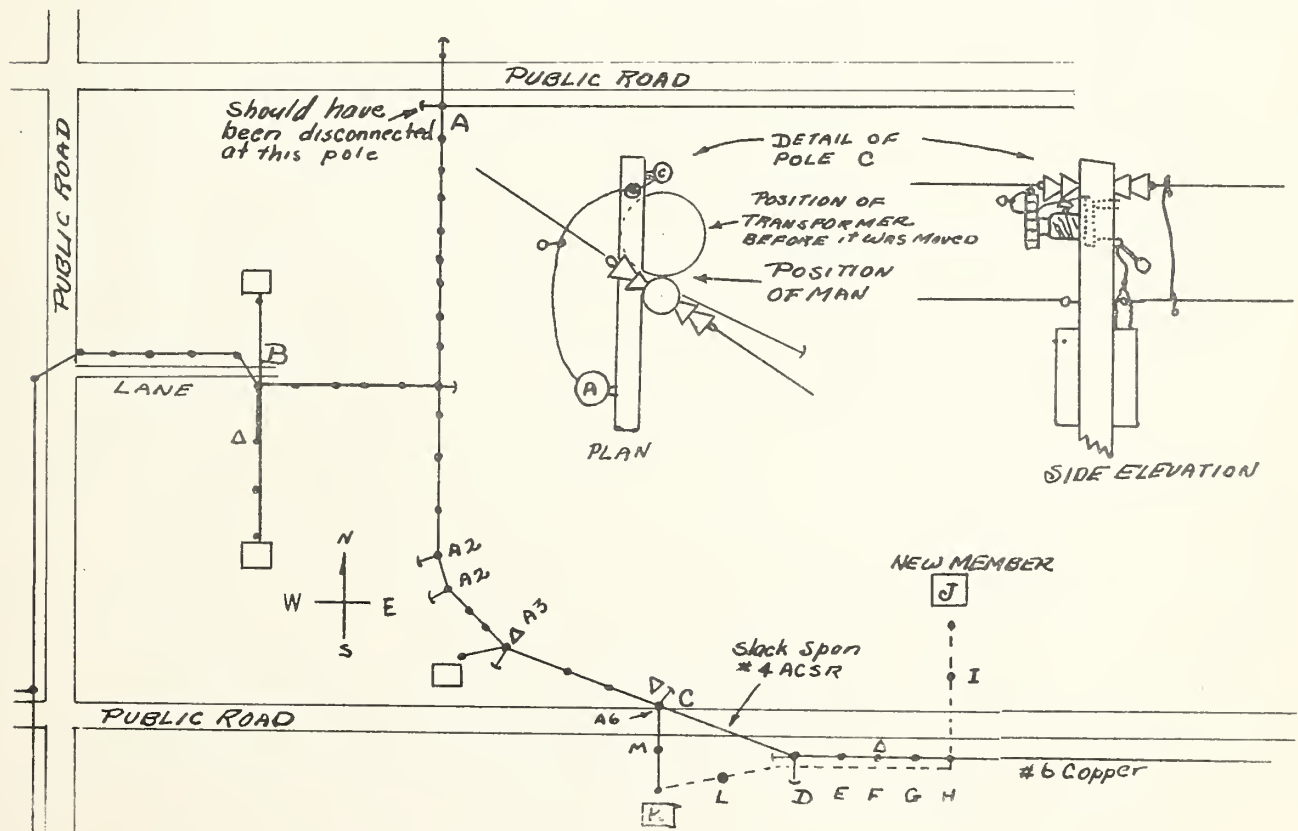
Failure of a lineman to disconnect a line at a proper point apparently was responsible for an accident that could have been serious.

The pole on which the accident occurred was originally an A-5 with conventional transformer, secondary services and a down guy. A section of old acquired line was connected by a slack span, thus changing the pole from an A-5 to an A-6.

A line crew was sent to rebuild the old line at this point, to serve a new member. The rebuilding job consisted of replacing some of the poles in the old line and moving the transformer to a point halfway between the old member K (see sketch) and the new member J. Secondary underbuild was to be installed (dotted lines on sketch) and the double dead-end eliminated on the A-6. The work had proceeded as follows:

Poles D, E, F, G and H were replaced. Poles I, J and L were set and the line was de-energized at pole C to complete this work. The transformer had been removed and the services to old member X from the A-6 to pole M were taken down.

It was necessary to de-energize beyond pole M, to complete the remainder of the work. A lineman was sent to do this. He traveled west along the public road and turned north and should have gone approximately one mile to another crossroad and turned back east to pole A.

Instead he turned right into a lane before reaching the crossroad and followed a section of line down to pole B and de-ener-

gized at this point. Instead of killing the line at the location where the work was to be done, he killed another short extension which ran south. When the line was killed, he applied protective grounds at this point and drove back to the work area where he reported that the line was de-energized and grounded. A lineman went up pole C to remove the cross-arm, cutout and arrester. In moving about up on the pole, the lineman contacted either the primary or the hardware back of the bell insulator. It is not known which, because the bells were found broken and showed indication of leakage.

The shock caused the lineman to slump in his belt and slide down the pole until one of his spurs caught in the ground wire, causing his leg to fold up and wedge between his body and the pole. This tightened his safety belt sufficiently to check his fall. He hung head downward in this position until the foreman climbed the pole and removed him. The shock rendered him unconscious. He regained consciousness, however, before he was removed from the pole. The first three fingers of both hands were burned. These burns were not serious and resulted in no lost time.
